Check Out

Prepared on behalf of Example Lettings Ltd

Reference: SAMPLE-0001

123 Sample Street
Sample City
Sampleshire
AB1 2CD

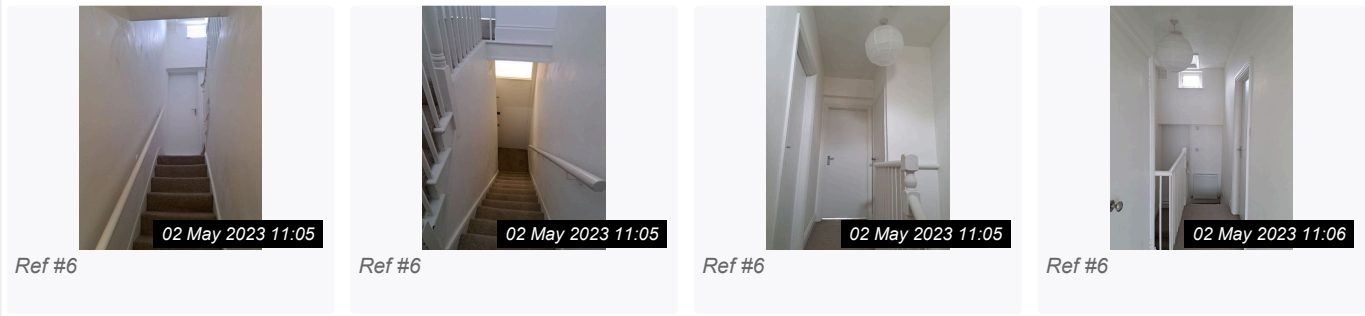
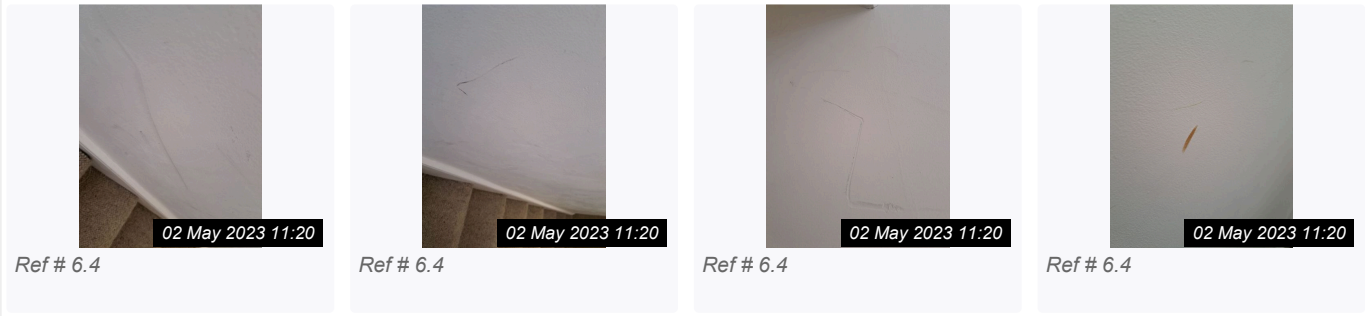
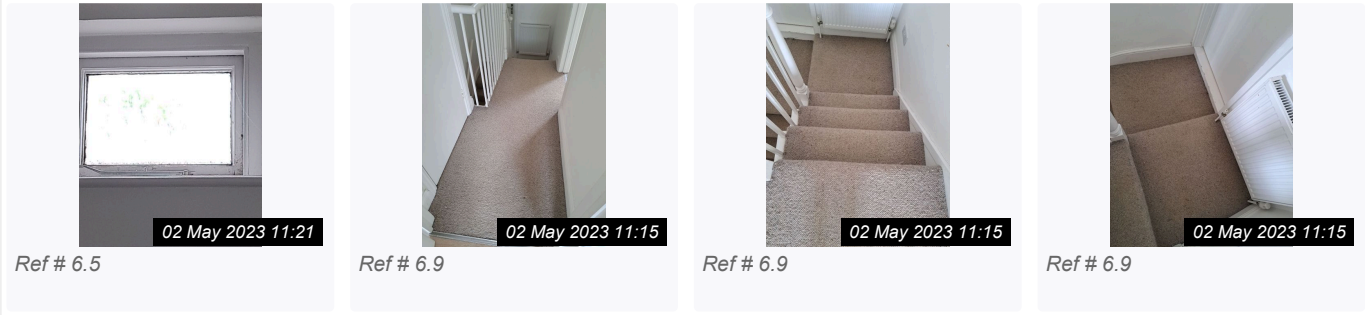
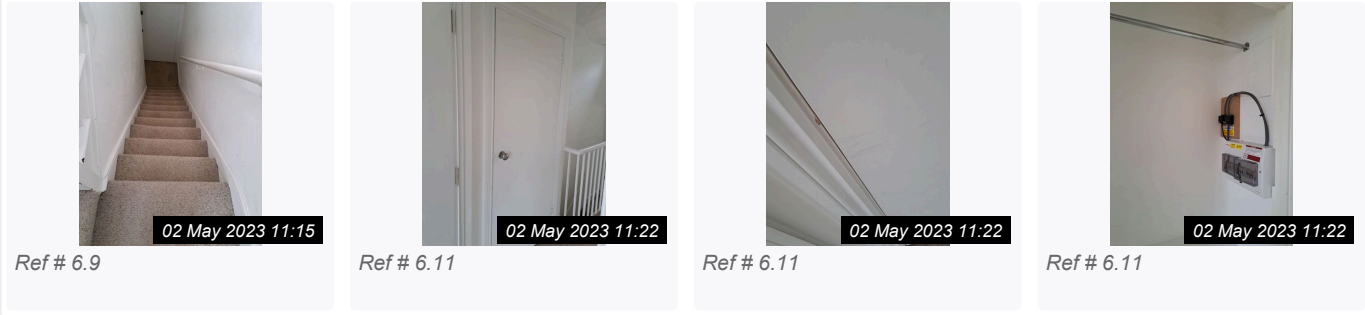
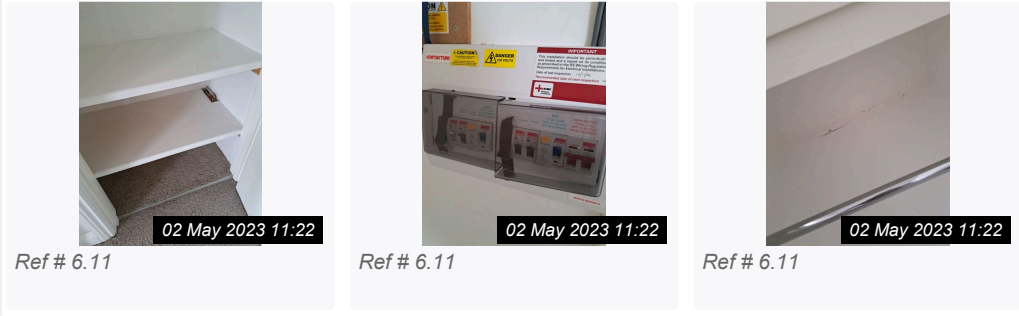
6.3	Lighting	White plastic pendant Energy saving bulb White paper shade	Bulb working	<i>As Inventory</i>	
6.4	Walls	Painted white	Scattered scuffs and mid to low level along length of stairs	<i>As Inventory</i> + Heavy scratches to paintwork high level above stairs Establish Responsibility - Investigate

6.5	Window(s) / Sill	High level window Surround and frame white wood Single glazed casement window Grey metal lever handle and retaining bar Sill white wood	Frame signs of what appears to be mould around frames	<i>As Inventory</i>

6.9	Flooring	Continuation of oatmeal textured carpet	Worn to main tread areas Light shading Spot stains forward of radiator Several small areas of pile missing forward of entrance to kitchen/reception, to stairs and forward of radiator	<i>As Inventory</i>

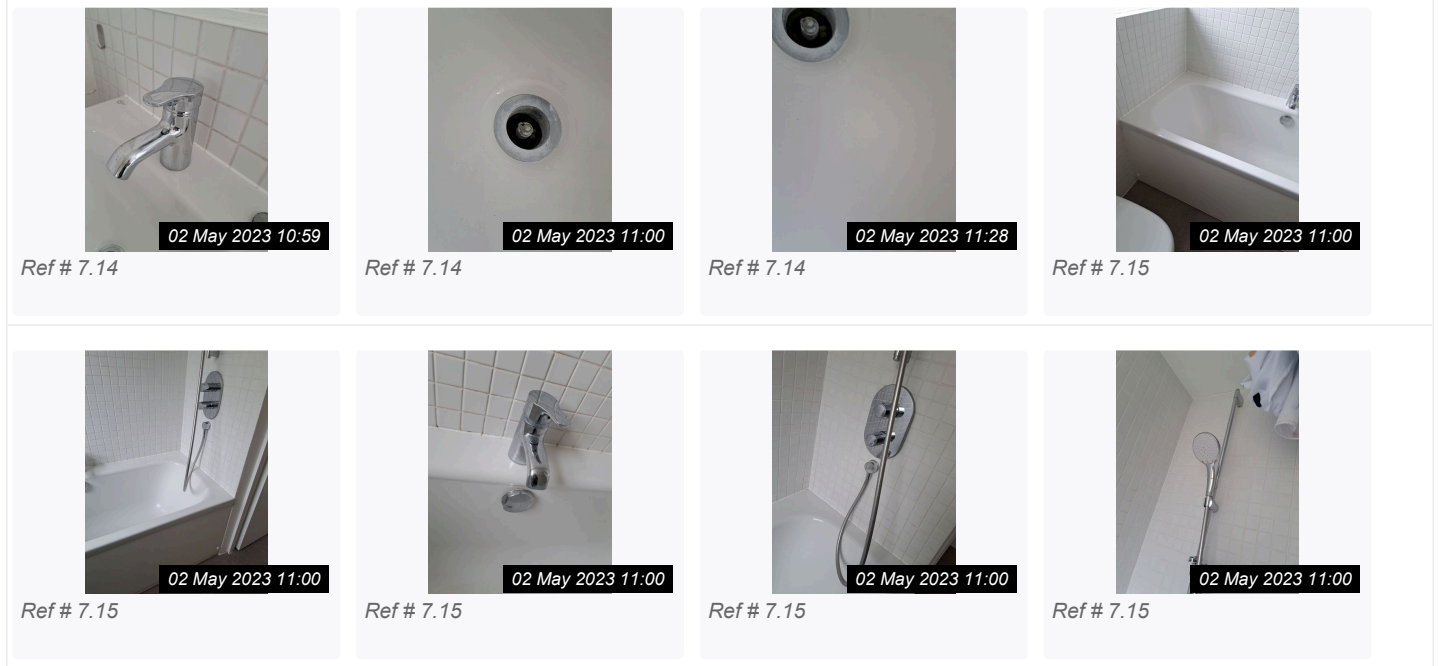
<p>02 May 2023 10:59</p> <p>Ref # 7.14</p>

7.14	Hand Basin	White vitreous wall mounted basin Stainless mixer tap Stainless steel waste Stainless steel pop-up plug	Pop-up not working Plug scratched	Pop-up not working - top detached Plug scratched White staining to base and to waste Needs Cleaning - Tenant

Actions Required			
7.14 Bathroom » Hand Basin	Needs Cleaning	Tenant	White staining to base and to waste
8.2 Bedroom » Ceiling	Establish Responsibility	Investigate	Black spot marks forward of loft access - appears to be mould marked
